## Road and Railroad Crossing Inventory

Little Coulee

U.S. Department of the Interior  
Bureau of Reclamation  
Great Plains Region  
Dakotas Area Office

September 2005

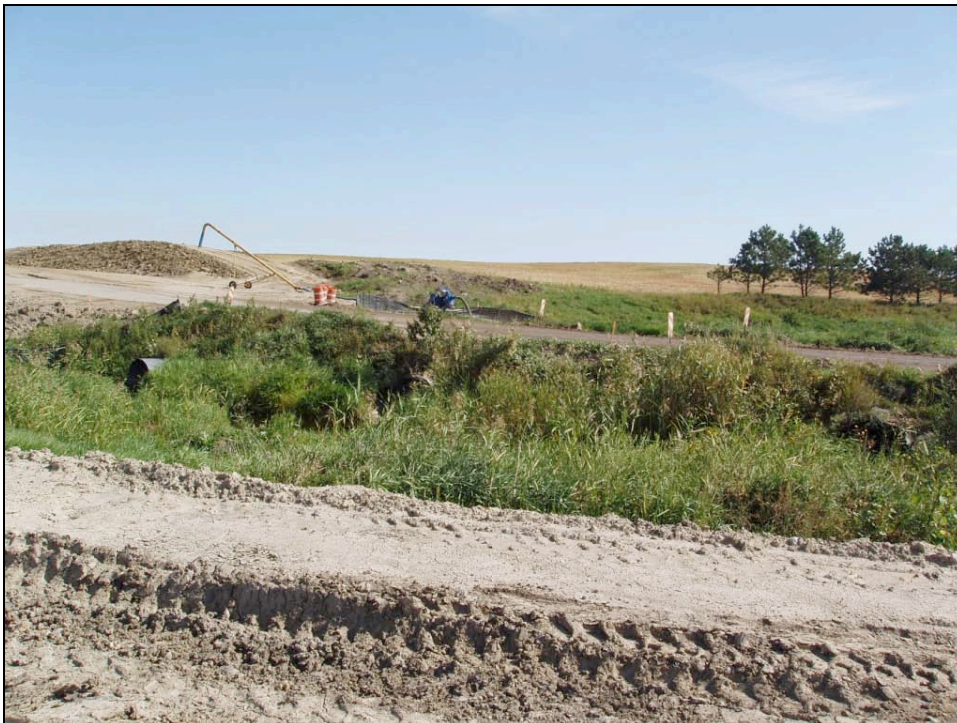
L2 Upstream side of three 60" CMPs in good condition, CMPs will be replaced with box culverts this year, from north to south (09-7-05), 2.1 feet, 1.5 feet & no water, Section 32 & 33, T155N, R67W, N 442913.51, E 2295904.13, elevation 1442.7 @ invert of CMP, N 442878.72, E 2295914.03, elevation 1443.9 @ invert of CMP, N 442831.59, E 2295911.52, elevation 1445.6 @ invert of CMP.

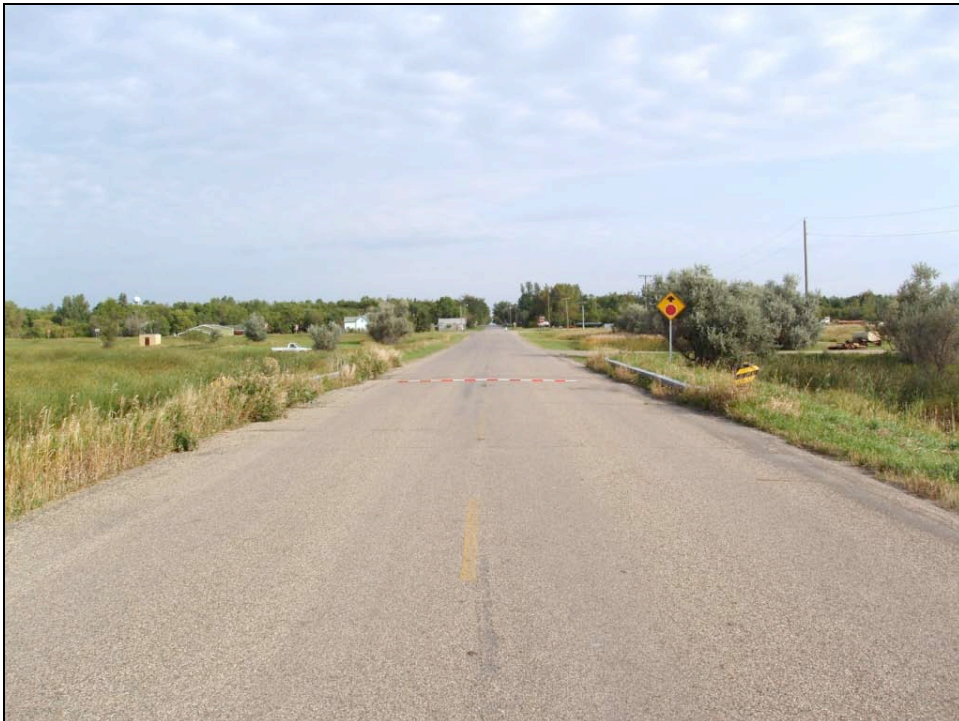
L8 Center of road crossing across two 108" CMPs, looking north, Section 31 & 32, T156N, R68W, N 469496.65, E 2258666.85, elevation 1484.1 @ center of road crossing, top of asphalt.

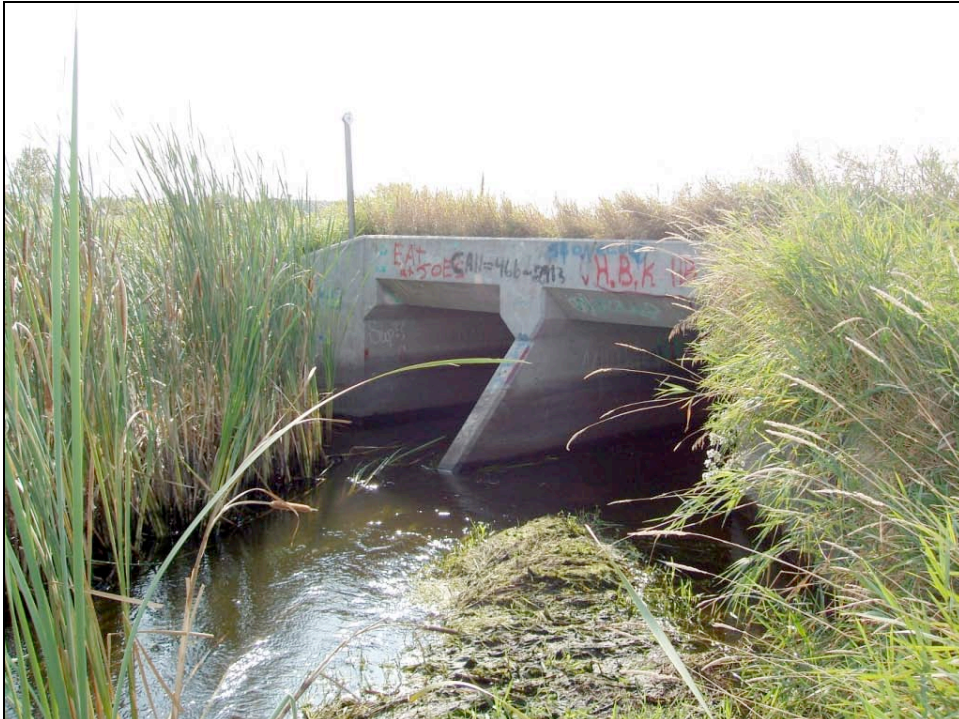
L10 Upstream side of two cell 5 foot box culverts, 13.5 feet long & 66.0 feet wide, in good condition, 0.6 feet, & 0.6 feet of water @ 2 cell Box Culvert (09-8-05), north to south Section 32, T156N, R68W, N 471923.18, E 2256205.30, elevation 1475.5 @ invert of 5' Box Culvert, N 471923.19, E 2256199.68, elevation 1475.5 @ invert of 5' Box Culvert.

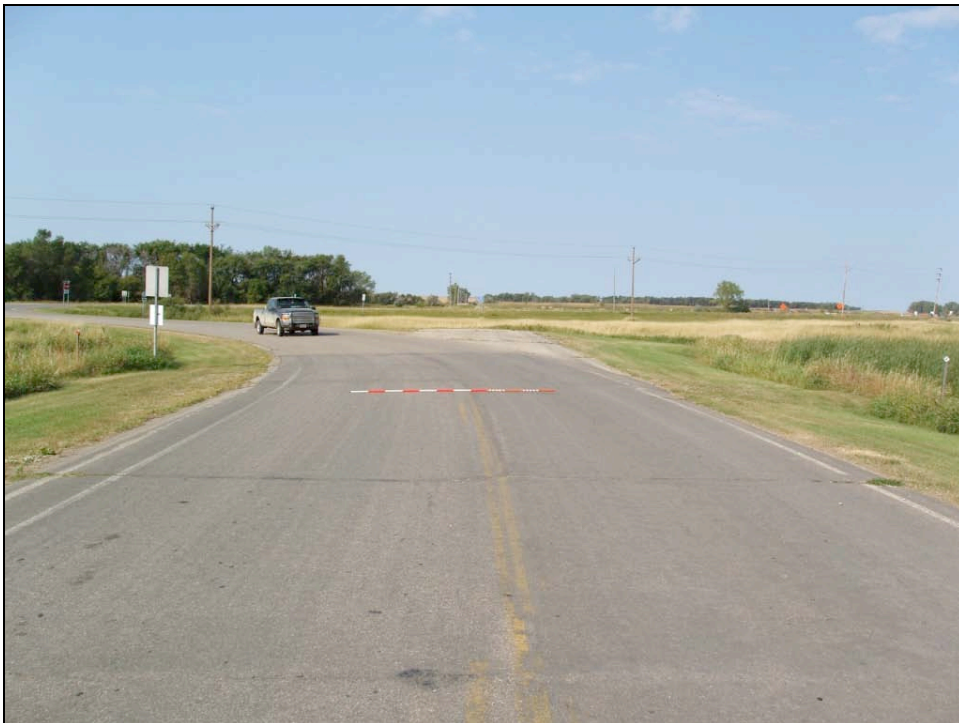
L10 Center of road crossing across two cell 5' box culvert 13.5 feet long & 66.0 feet wide looking south (09-8-05), Section 31 T156N, R68W, N 471889.34, E 2256203.40, elevation 1482.8 @ center of road crossing, above box culverts, top of asphalt.

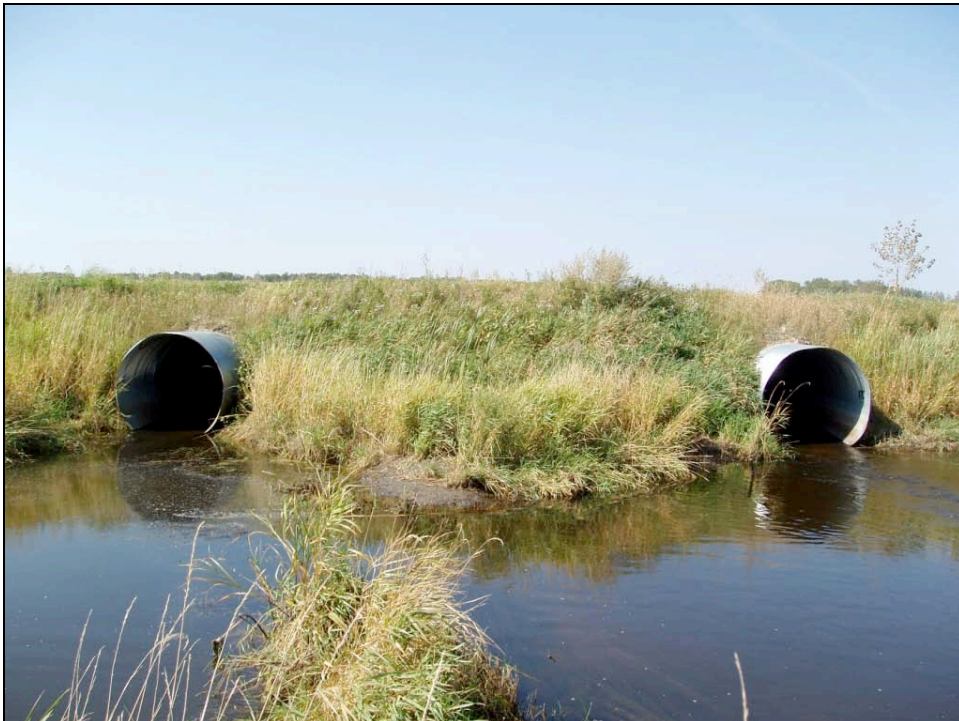
L11 Downstream side of two 72" CMPs, in good condition, 0.8 feet, & 0.7 feet of water, from north to south (09-8-05), Section 36 & 31, T156N, R69 & 68W. N 473364.23, E 2253476.97, elevation 1478.2 @ invert of 72" CMP, N 473329.22, E 2253476.52, elevation 1478.2 @ invert of 72" CMP.

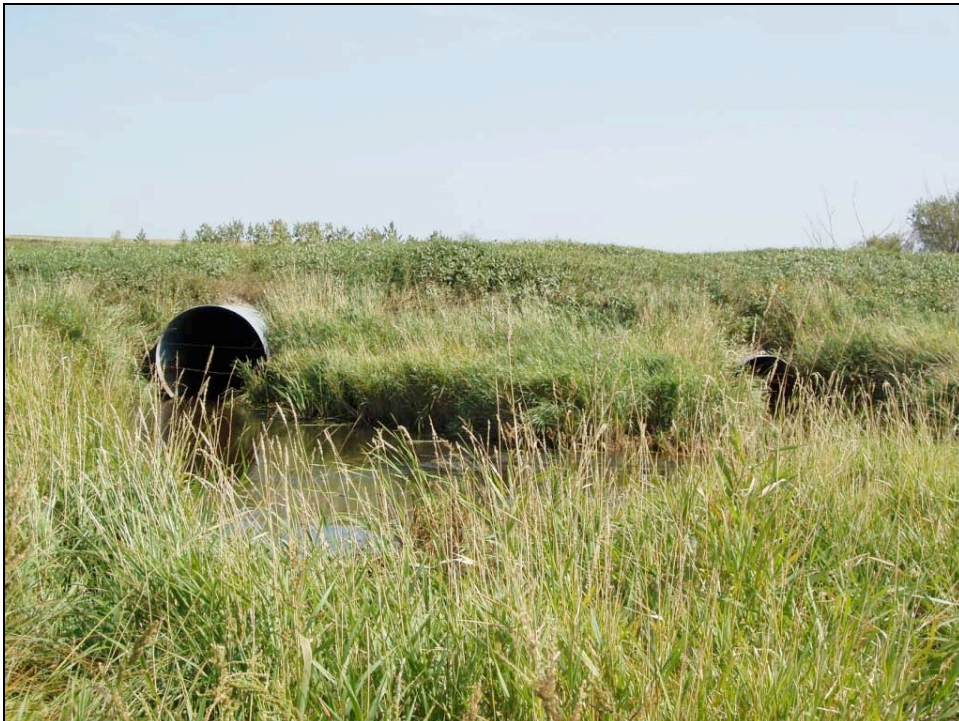
L15 Downstream side of two CMPs (48" & 60") in good condition, 0.9 feet, & 0.9 feet, of water, from south to north (09-8-05), Section 23 & 24, T156N, R69W, N 483091.36, E 2247986.11, elevation 1499.4 @ invert of 48" CMP, N 483122.51, E 2247987.76, elevation 1499.5 @ invert of 60" CMP.

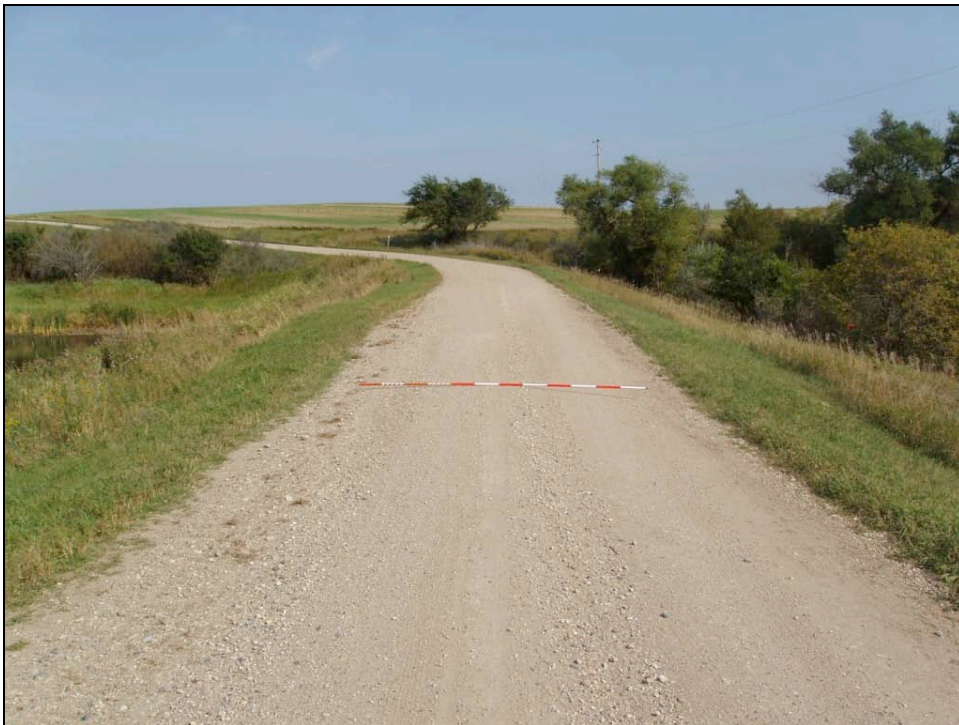
L16 Center of road crossing, across one of 120" CMP, looking east, Section 24, T156N, R69W, N 484209.65, E 2248469.48, elevation 1524.2 @ center of road crossing, top of gravel.

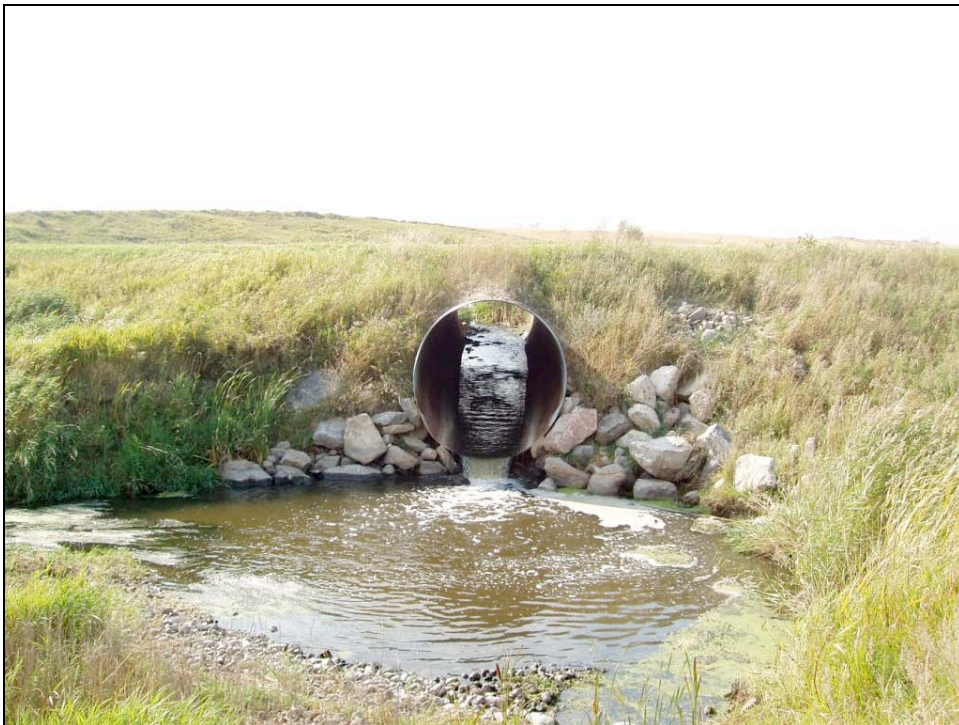
L17 Downstream side of one 108" CMP, in good condition, 0.8 feet of water (09-8-05), Section 14 & 13, T156N, R69W, N 486868.02, E 2247969.93, elevation 1511.9 @ invert of CMP.

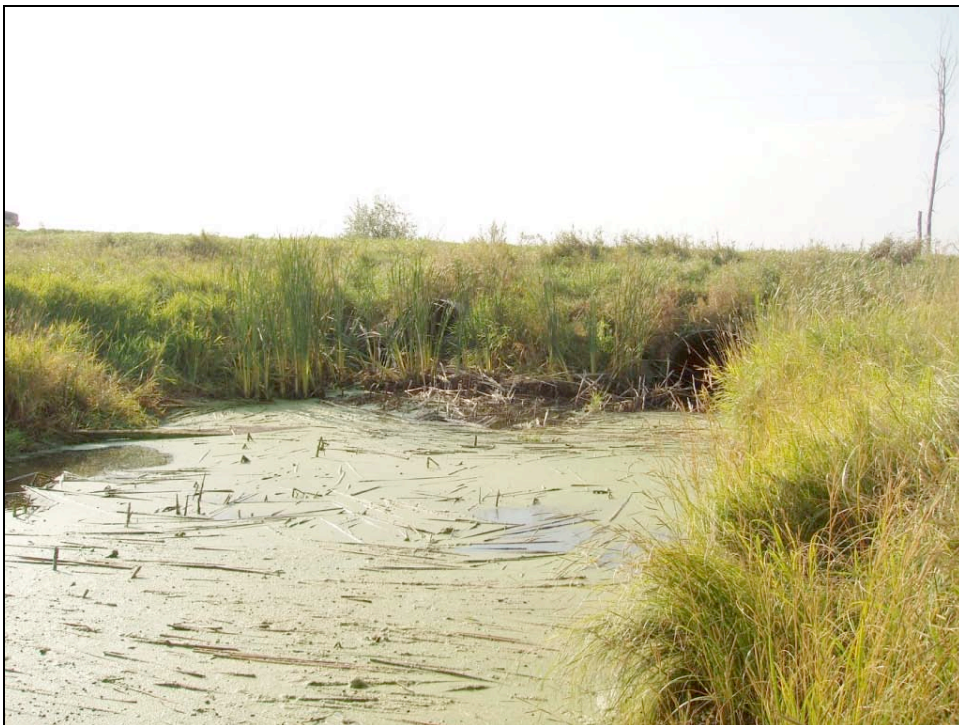
L18 Upstream side of two 72" CMPs, in good condition, 1.6 & 1.3 feet of water (09-9-05), east to west, Section 11 & 14, T156N, R69W, N 490315.55, E 2246939.03, elevation 1520.2 @ invert of 72" CMP, N 490316.41, E 2246921.78, elevation 1519.4 @ invert of 72" CMP.

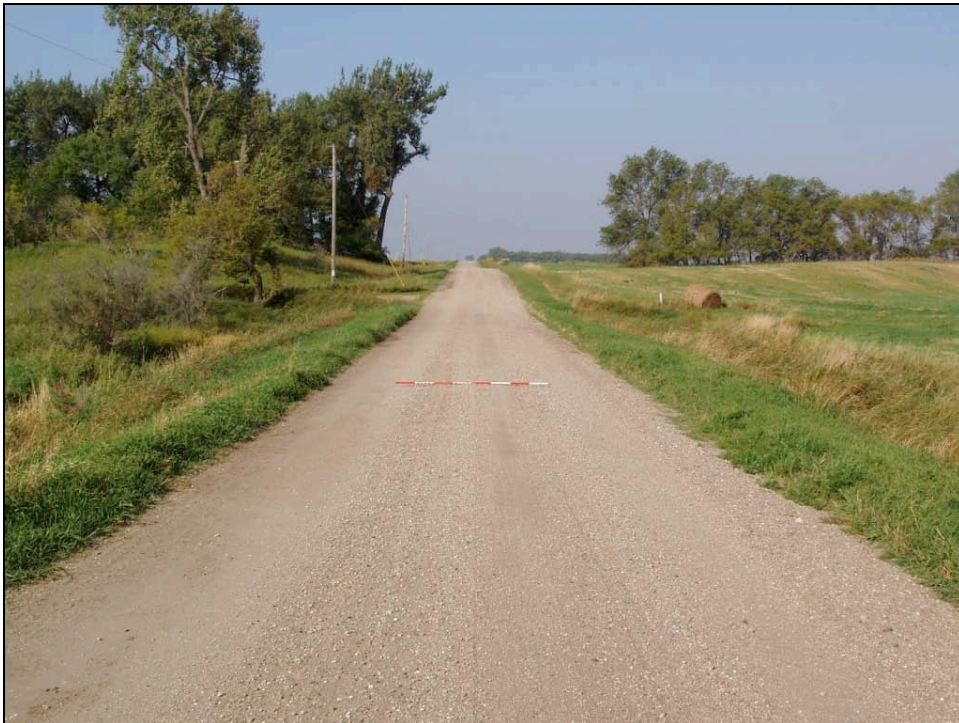
L18 Center of road crossing across two 72" CMPs, looking west, Section 11 & 14, T156N, R69W, N 490280.66, E 2246931.27, elevation 1530.2 @ center of road crossing, between CMPs, top of gravel.

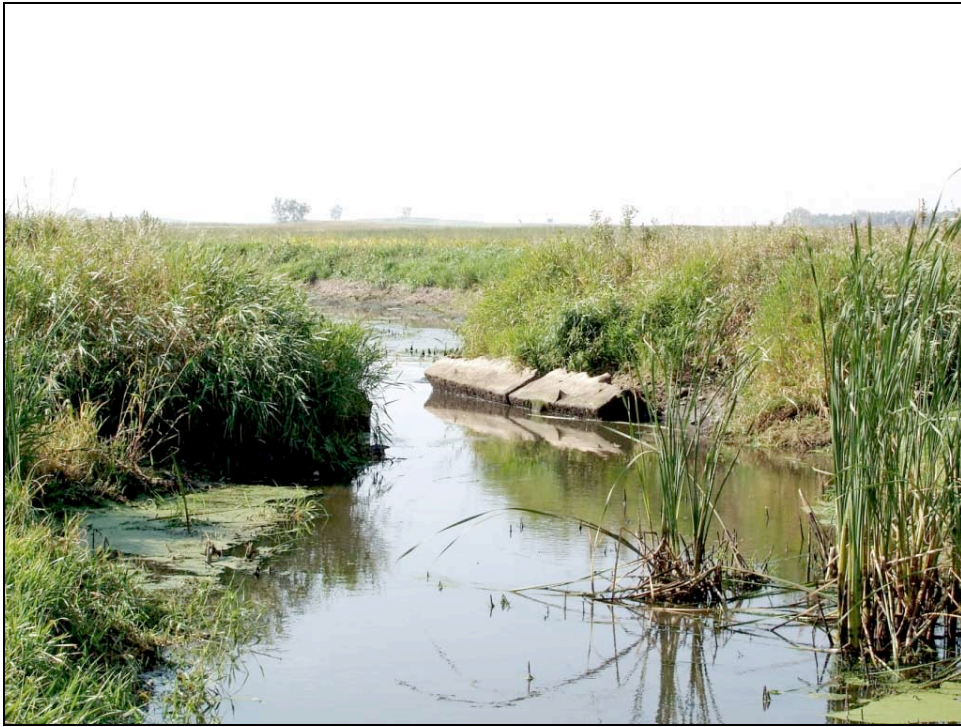
L19 Upstream side of bridge site (09-9-05), Section 2 & 11, T156N, R69W, N 495570.38, E 2246339.13, bottom elevation 1522.6 of bridge site.

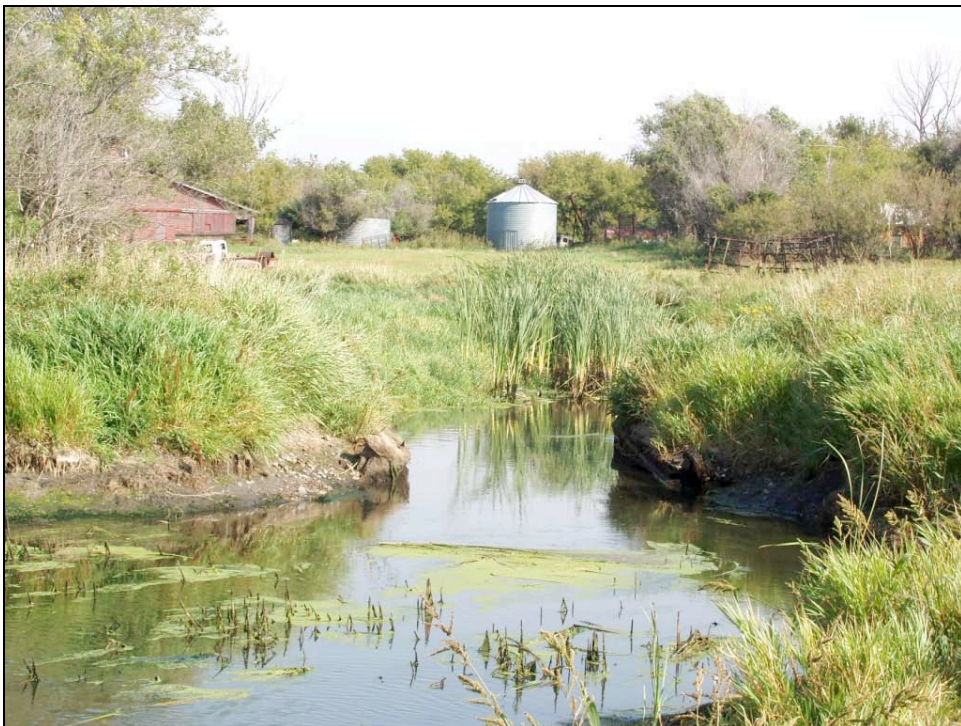
L19 Downstream side of bridge site, 30 foot long by 15 feet wide, 1.8 of water in channel (09-9-05), Section 2 & 11, T156N, R69W.

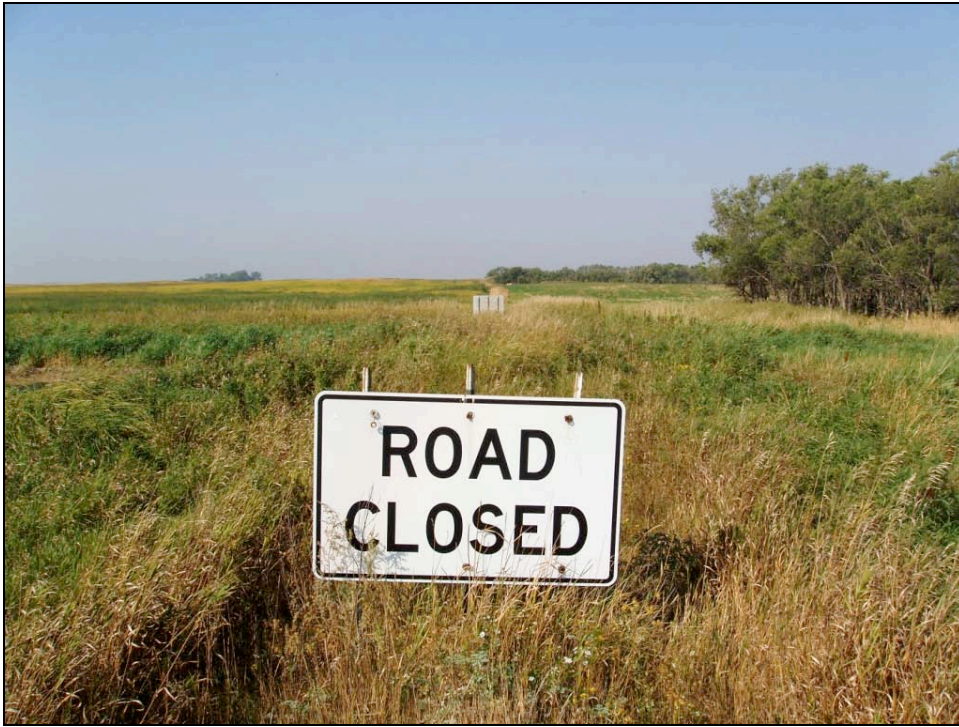
L19 east side of bridge site, looking west, Section 2 & 11, T156N, R69W,  
N 495568.50, E 2246351.86 elevation 1528.5 top elevation of bridge site.

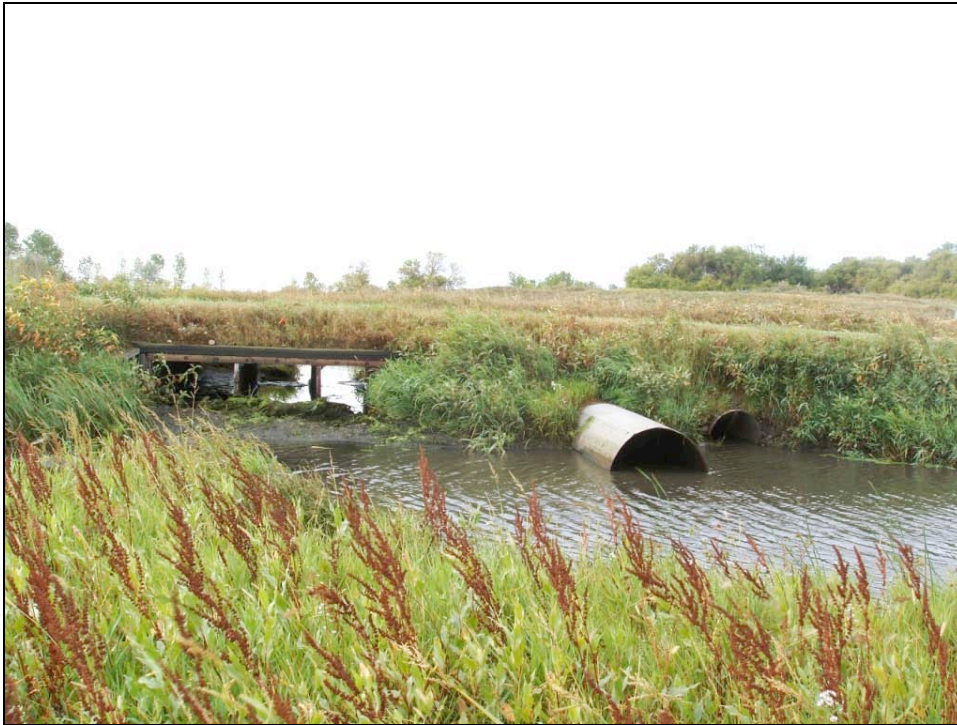
L21 Upstream side of wood bridge in fair condition, no water, two  
CMPs (48" & 24") in good condition, 1.3 feet & 0.9 feet of water (09-13-05),  
Section 1 & 36, T156 & 157N, R69W,  
N 501777.85, E 2250945.05, coulee bottom elevation 1530.5 @ C/L of bridge,  
N 501791.72, E 2250930.46, elevation 1528.9 @ invert of 48" CMP,  
N 501783.21, E 2250923.82, elevation 1530.3 @ invert of 24" CMP.

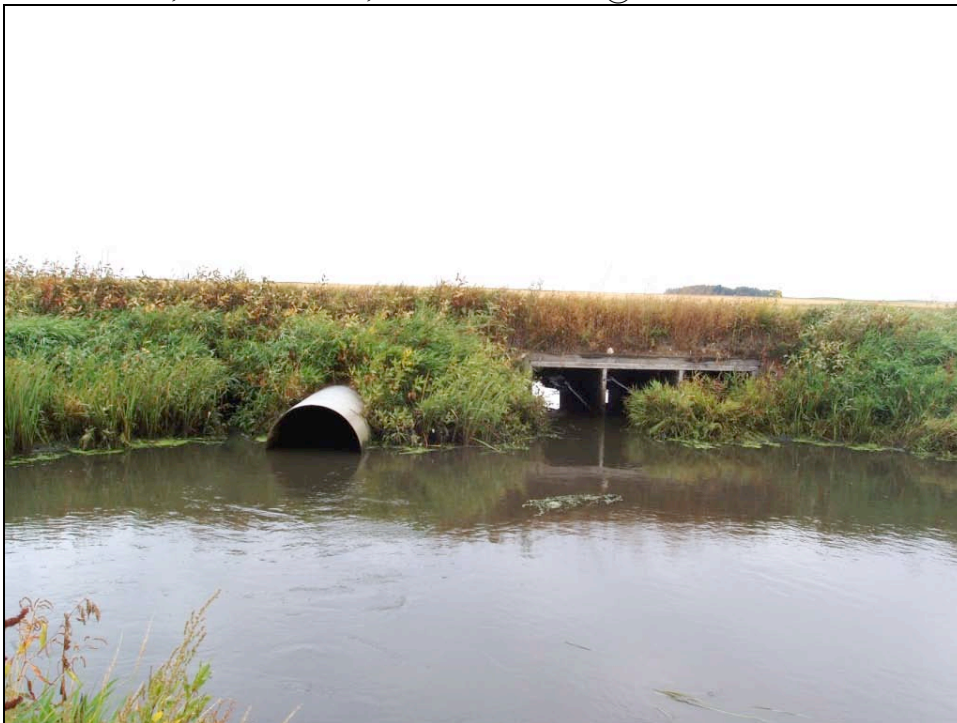
L21 Downstream side of wood bridge in fair condition, 0.9 feet of water,  
two CMPs (48" & 24") in good condition, 1.0 feet & 0.6 feet of water (09-13-05),  
Section 1 & 36, T156 & 157N, R69W,  
N 501746.83, E 2250945.32, coulee bottom elevation 1530.5 @ C/L of bridge,  
N 501730.78, E 2250929.56 elevation 1529.1 @ invert of 48" CMP,  
N 501741.97, E 2250923.70 elevation 1530.7 @ invert of 24" CMP.

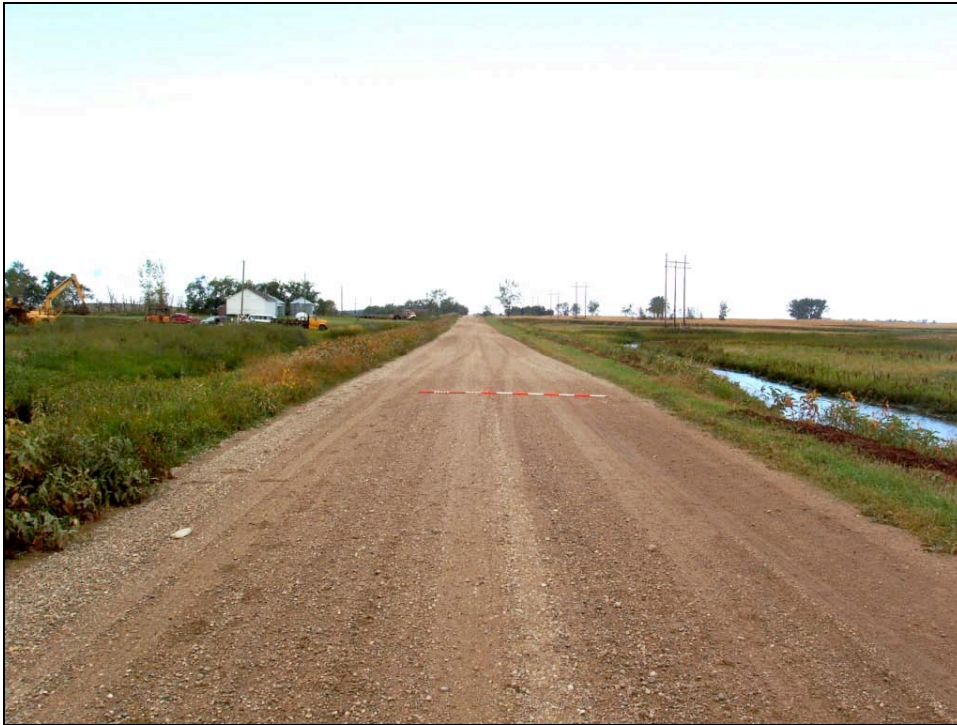
L21 Center of wood bridge, looking west in fair condition, 31.0 feet wide & 13.0 feet long, Section 1 & 36 T156 & 157N, R69WN, 501760.84, E 2250946.54, elevation 1537.0 @ C/L of bridge, top of gravel.

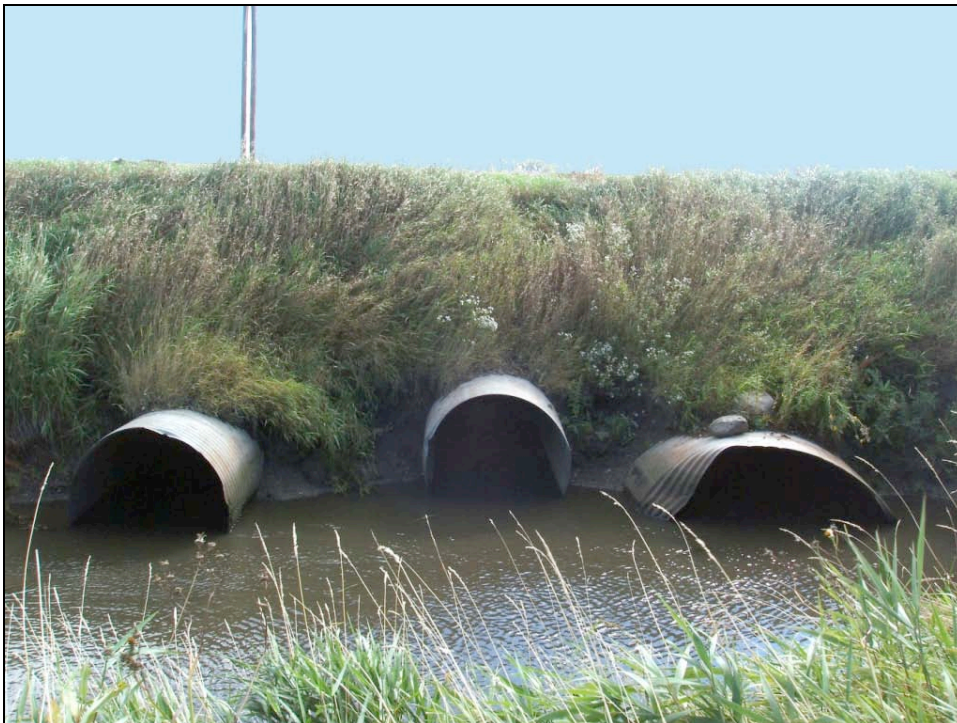
L22 Upstream side of three 48" CMPs in fair condition, 2.0 feet, 1.1 feet, & 1.4 feet of water (09-13-05), from south to north, Section 31 & 32, T157N, R68W, N 503113.80, E 2250030.44, elevation 1529.4 @ invert of 48" CMP, N 503120.32, E 2250034.63, elevation 1530.3 @ invert of 48" CMP, N 503130.07, E 2250033.99, elevation 1529.8 @ invert of 48" CMP.

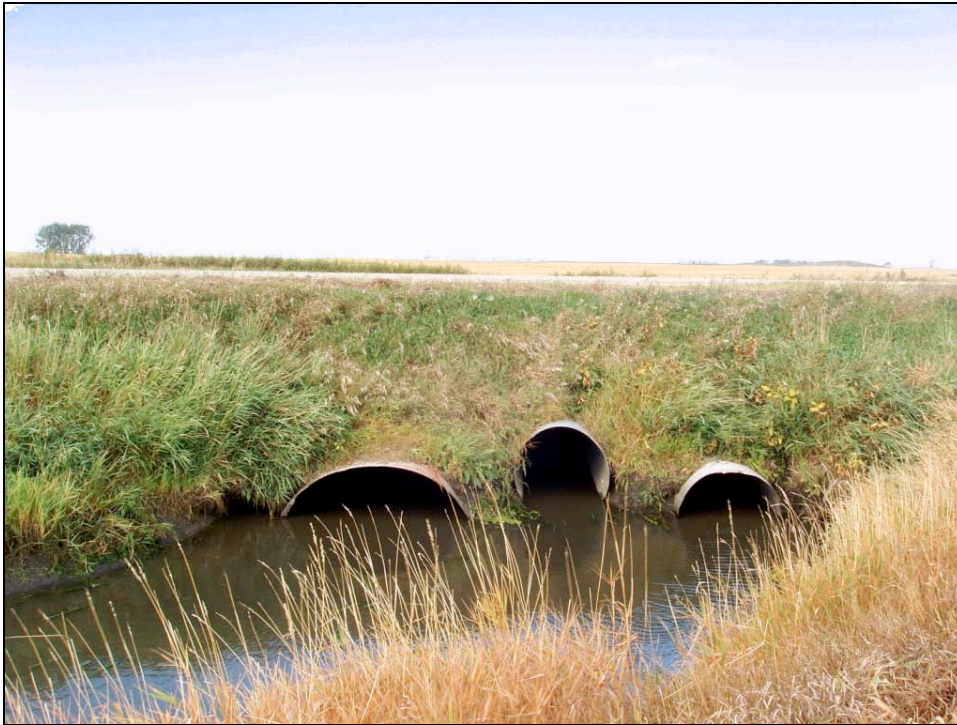
L22 Downstream side of three 48" CMPs in fair condition, 1.5 feet, 0.9 feet, & 0.8 feet of water (09-13-05), from south to north, Section 31 & 32, T157N, R68W, N 503095.25, E 2250088.69, elevation 1529.9 @ invert of 48" CMP, N 503103.25, E 2250087.04, elevation 1530.5 @ invert of 48" CMP, N 503108.79, E 2250092.04, elevation 1529.5 @ invert of 48" CMP.

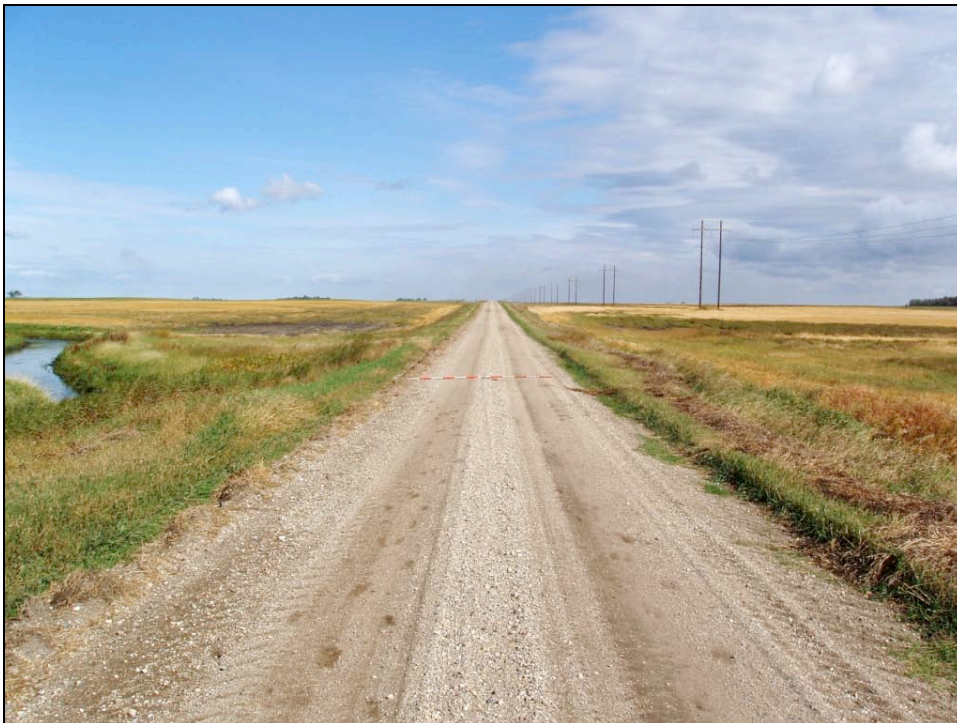
L22 Center of road crossing, across three CMPs, looking north, Section 31 & 32, T157N, R68W, N 503112.26, E 2250060.79, elevation 1540.6 @ center of road crossing, top of gravel.

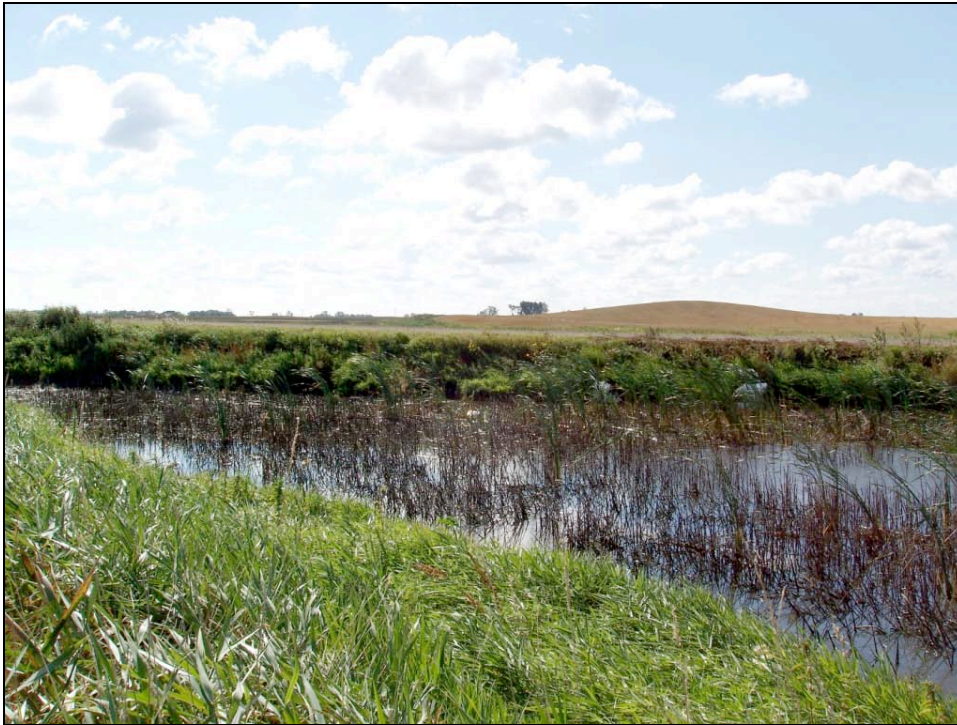
L23 Upstream side of six 48" CMPs in fair condition, 1.0 feet, 1.2 feet, 1.5 feet, 1.3 feet, 1.0 feet, & 1.0 feet of water (09-13-05), from east to west, Section 30 & 31, T157N, R68W,  
N 507024.14, E 2246571.32, elevation 1530.8 @ invert of 48" CMP,  
N 507020.97, E 2246547.57, elevation 1530.4 @ invert of 48" CMP,  
N 507020.36, E 2246533.57, elevation 1530.1 @ invert of 48" CMP,  
N 507019.34, E 2246517.46, elevation 1530.4 @ invert of 48" CMP,  
N 507018.25, E 2246500.91, elevation 1530.8 @ invert of 48" CMP,  
N 507017.14, E 2246481.48, elevation 1530.7 @ invert of 48" CMP,

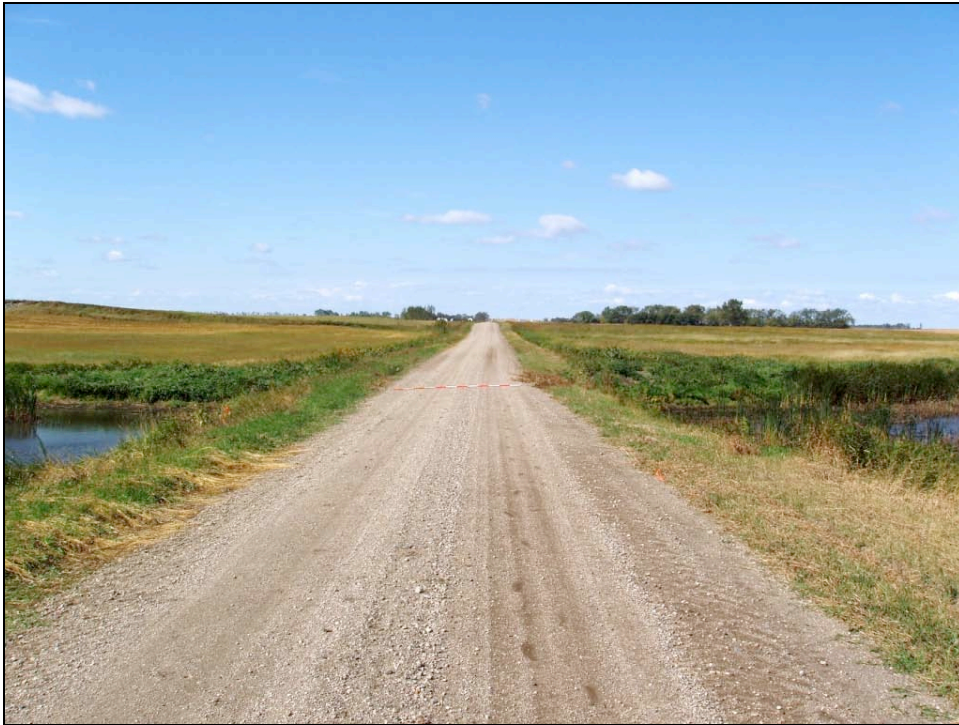
L23 Center of road crossing, across six CMPs, looking west, Section 30 & 31, T157N, R68W, N 507000.14, E 2246526.36, elevation 1538.7 @ center of road crossing, top of gravel.

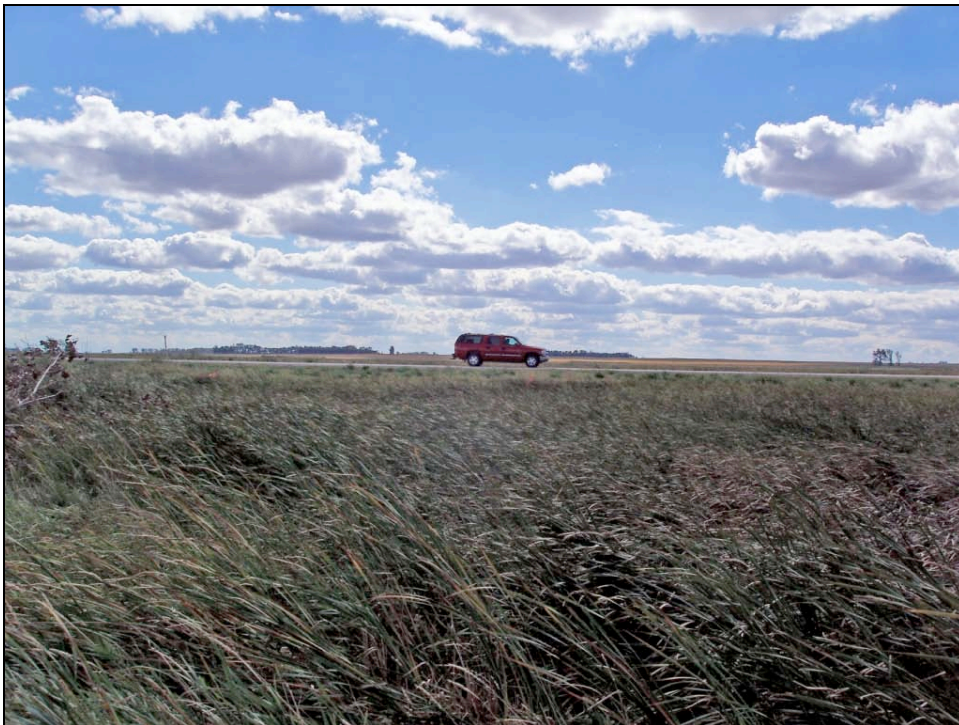
L24 Upstream side of four 60" CMPs in good condition, 2.5 feet, 1.3 feet, 1.0 feet, & 1.2 feet of water (09-13-05), from east to west, Section 23, T158N, R69W, N 546566.51, E 2236781.54, elevation 1534.9 @ invert of 60" CMP, N 546585.41, E 2236734.60, elevation 1536.0 @ invert of 60" CMP, N 546636.94, E 2236649.78, elevation 1536.5 @ invert of 60" CMP, N 546660.22, E 2236608.37, elevation 1536.4 @ invert of 60" CMP.

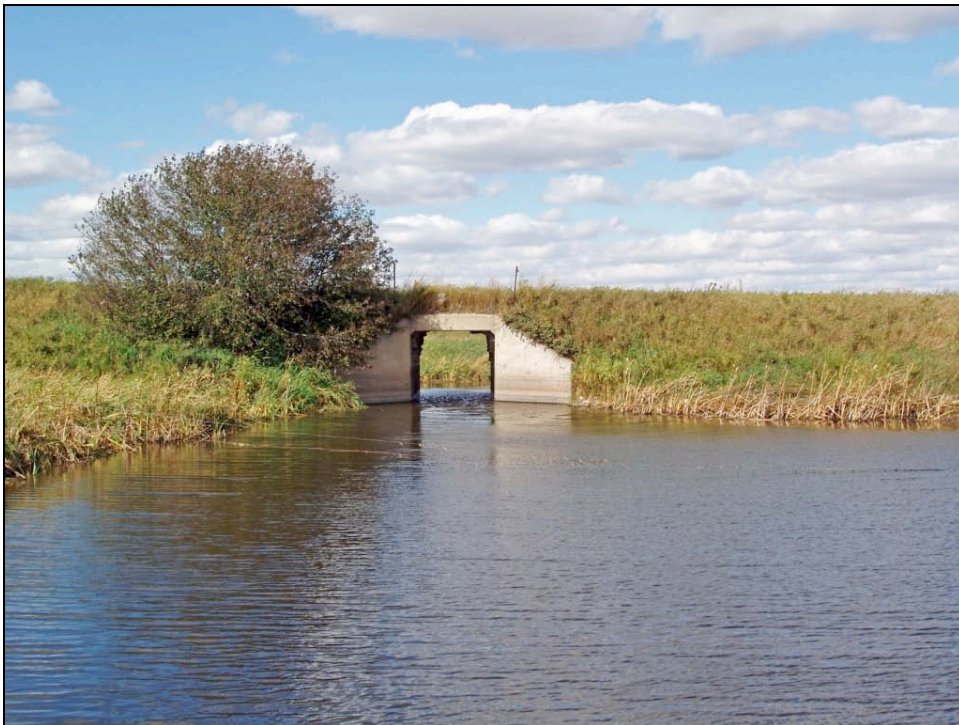
L25 Downstream side of single cell 10 foot box culvert, in good condition, 1.5 feet of water (09-13-05), section 14 & 23, T158N, R69W, N 549150.60, E 2235191.35, coulee bottom elevation 1536.2 @ C/L of box culvert.

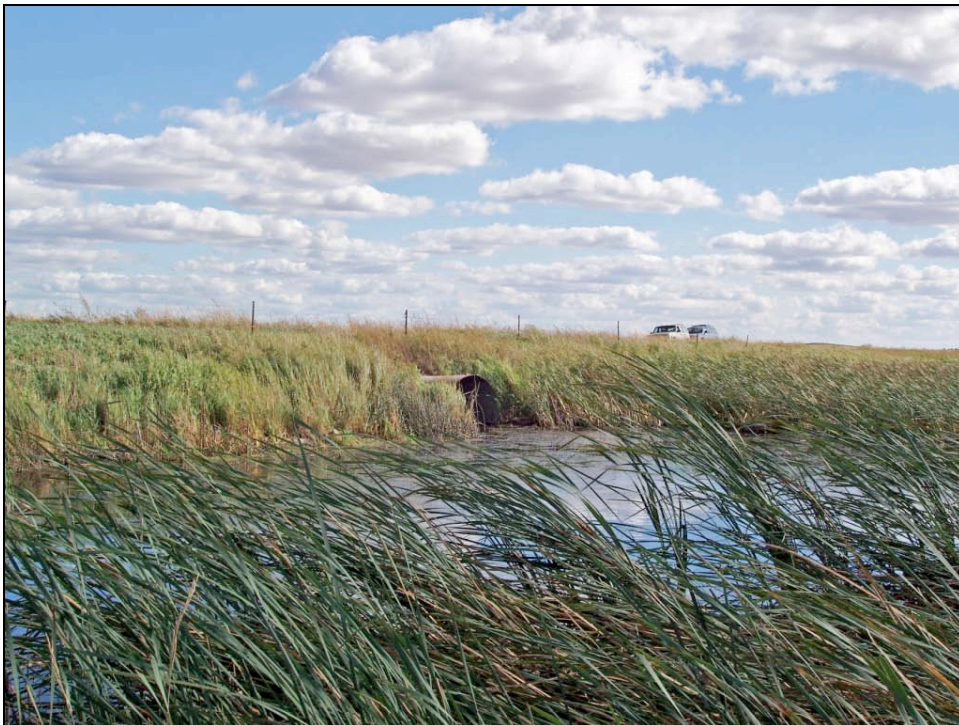
L26 Upstream side of three CMPs (60", 48" & 60") in good condition, 0.6 feet, 0.8 feet, & 1.1 feet of water (09-13-05), from south to north, Section 15 & 14, T158N, R69W, N 553393.36, E 2233542.09, elevation 1541.8 @ invert of 60" CMP, N 553422.44, E 2233538.15, elevation 1541.5 @ invert of 48" CMP, N 553469.17, E 2233537.22, elevation 1541.1 @ invert of 60" CMP.

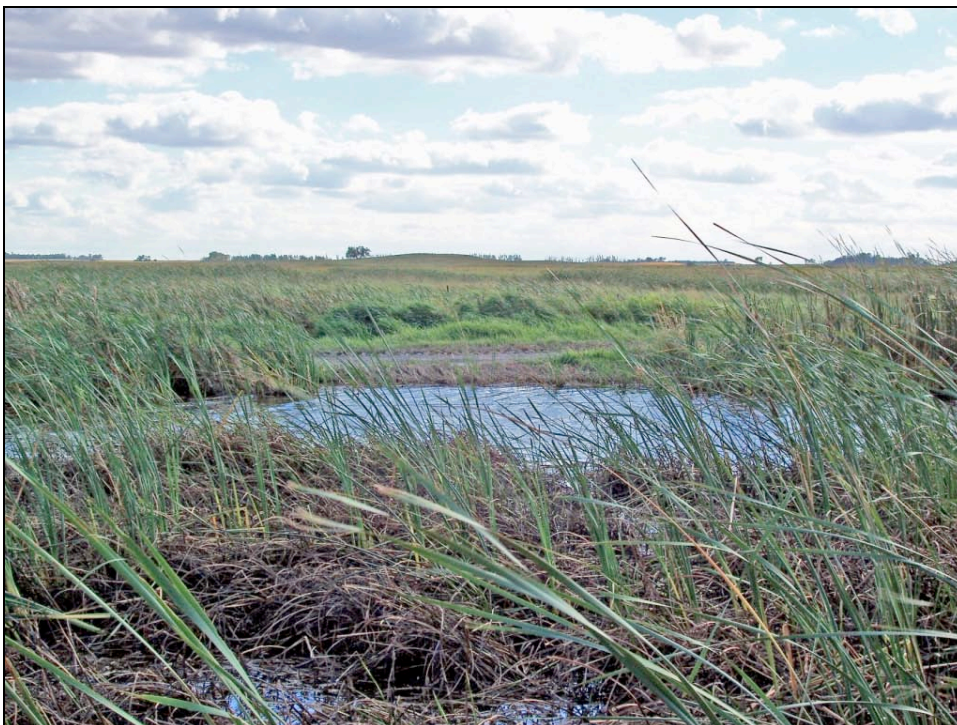
L27 Upstream side of Texas crossing, in poor condition, edge of water (09-13-05), Section 10 & 15, T158N, R69W, N 554445.38, E 2233107.68, elevation 1543.4 top of rocks.

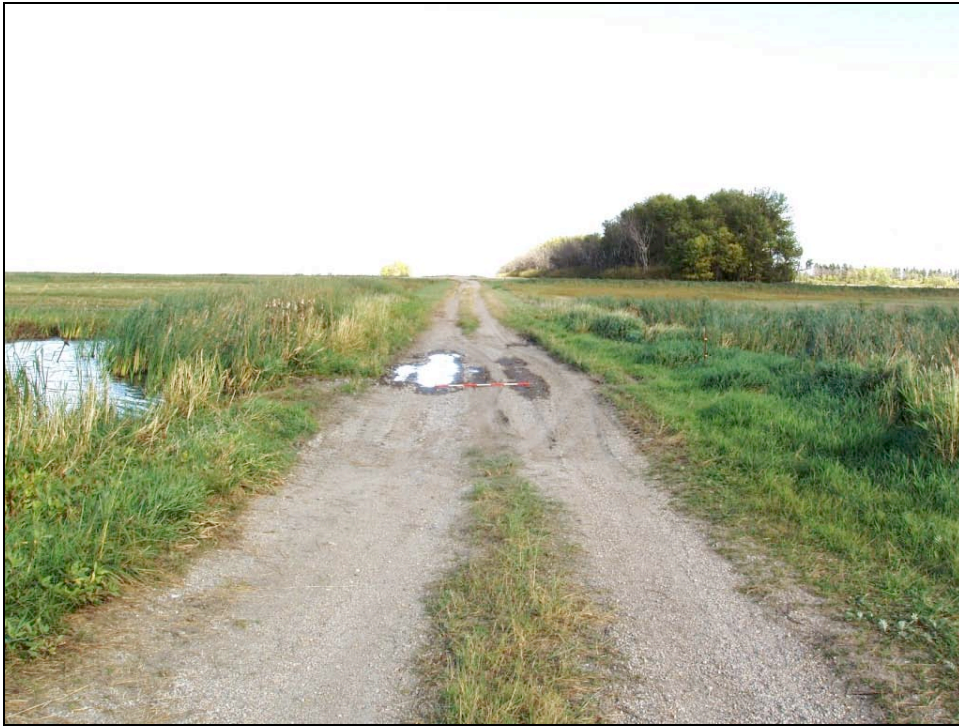
L27 Center of Texas crossing, looking east, Section 10 & 15, T158N, R69W, N 554430.97, E 2233115.65, elevation 1543.5 @ center of Texas crossing, top of rocks.

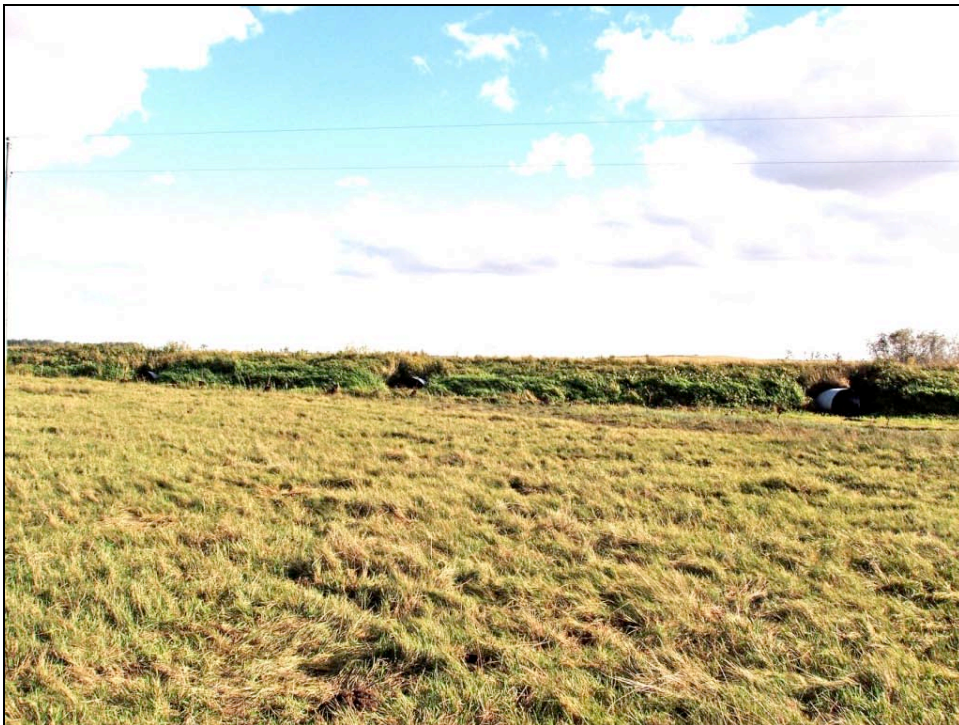
L28 Upstream side of three CMPs (60", 60" & 48") in good condition, 0.8 feet, no water & no water (09-13-05), from west to east, Section 3 & 10, 158N, R69W, N 559688.18, E 2228790.39, elevation 1546.4 @ invert of 60" CMP, N 559690.32, E 2228862.43, elevation 1547.5 @ invert of 60" CMP, N 559691.64, E 2228921.81, elevation 1546.8 @ invert of 48" CMP.

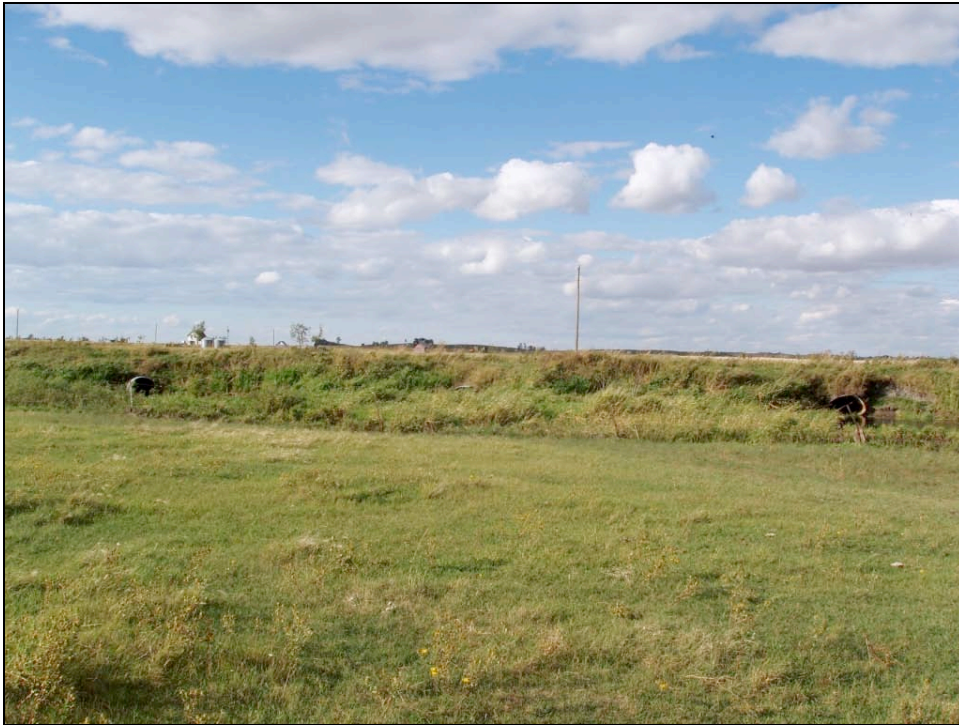
L28 Downstream side of three CMPs (60", 60" & 48") in good condition, 1.5 feet, 0.2 feet & 2.0 feet of water (09-13-05), from west to east, Section 3 & 10, T158N, R69W, N 559649.91, E 2228814.27, elevation 1545.6 @ invert of 60" CMP, N 559649.22, E 2228866.60, elevation 1546.8 @ invert of 60" CMP, N 559654.10, E 2228923.44, elevation 1546.7 @ invert of 48" CMP.

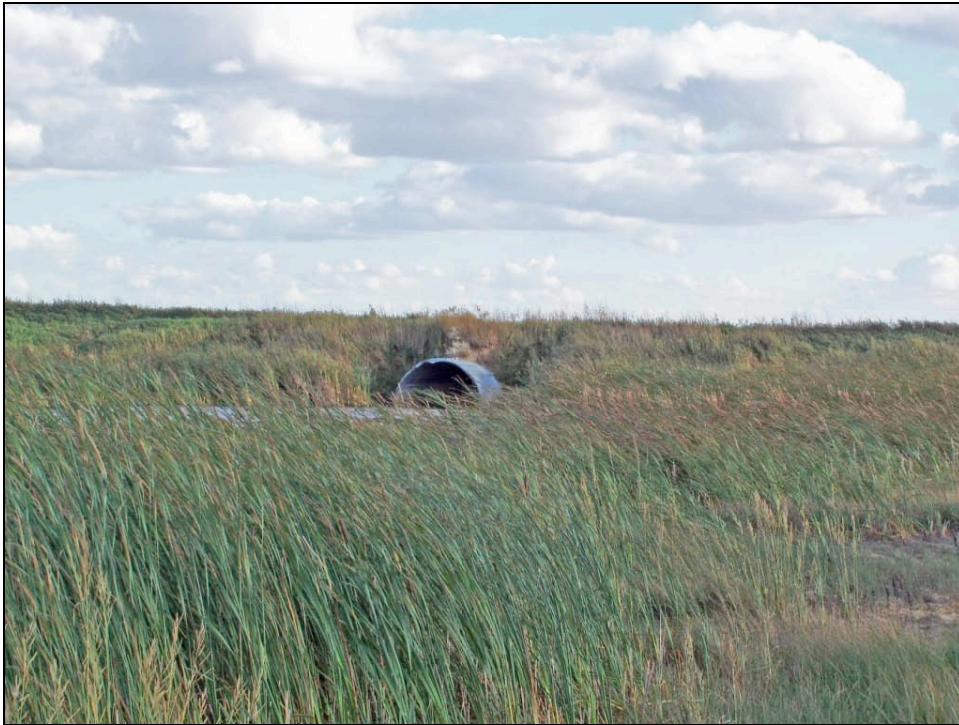
L29 Upstream side of one 84" CMP, in good condition, 2.1 feet of water (09-13-05), Section 4 & 33, T158 & 159N, R69W, N 564957.89, E 2226321.65, elevation 1554.6 @ invert of CMP.

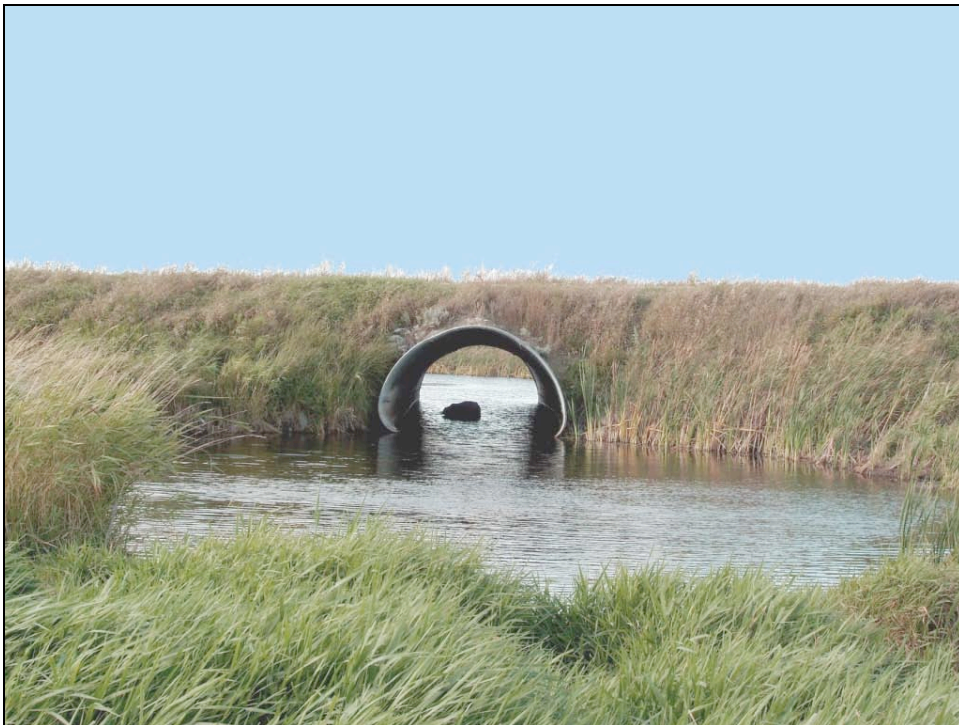
L29 Downstream side of one 84" CMP, in good condition, 1.0 feet of water (09-13-05), Section 4 & 33, T158 & 159N, R69W, N 564895.47, E 2226328.22, elevation 1555.4 @ invert of CMP.
